**Re: Section 5 Declaration R576/20 'Phase 1' Building,
Tyndall National Institute, Lee Maltings, Dyke Parade &
Prospect Row, Cork**

Scope Document for Roof Repair

Curtins have been requested to attend site to inspect the existing roof to Block 1 to determine the scope of works for the repair and refurbishment of the existing roof fabric. The architectural report outlines the brief which UCC have put forward to the design team to allow us to progress the scope of works for pricing from Summerhill Construction. This report is to be read in conjunction with any relevant information submitted to UCC.

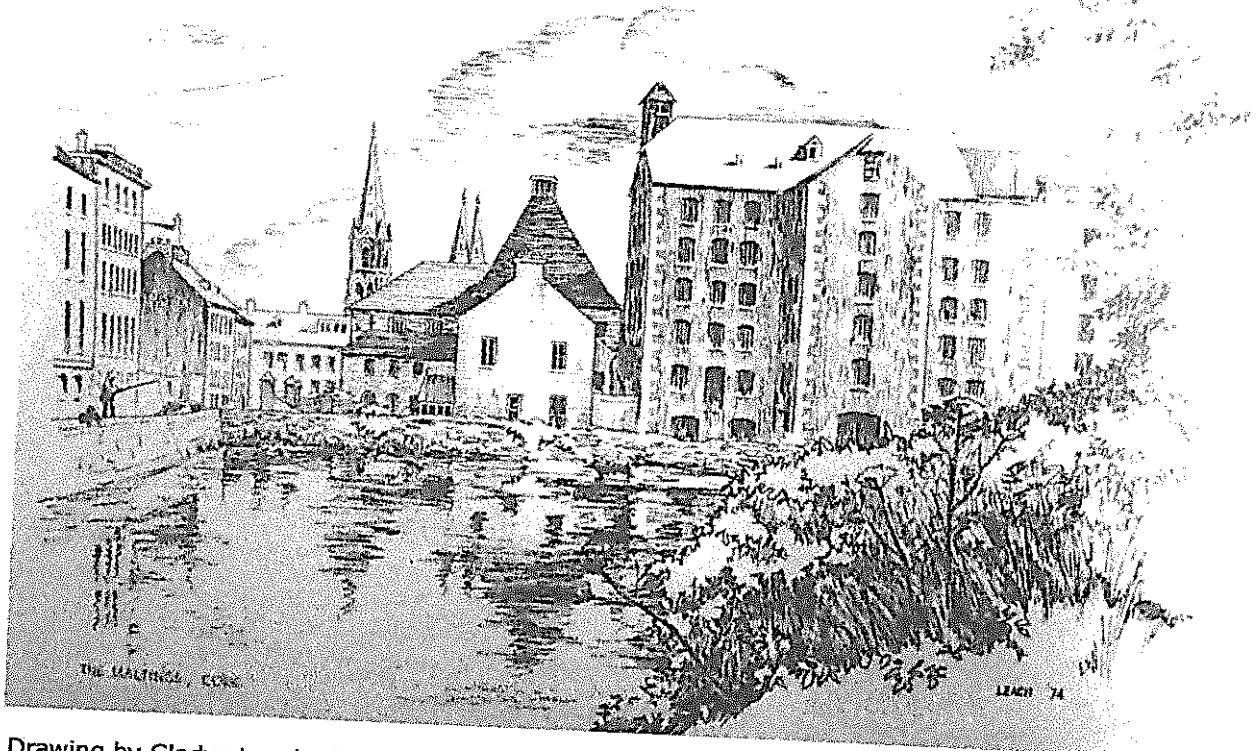
Drawing by Gladys Leach, dated 1974, of the Lee Maltings (building subject of this application)

Note the form of the roof at the north east corner (right hand side of this elevation) where it is propose to re-instate the roof profile, removing a now redundant area of flat roof previously used for building services.

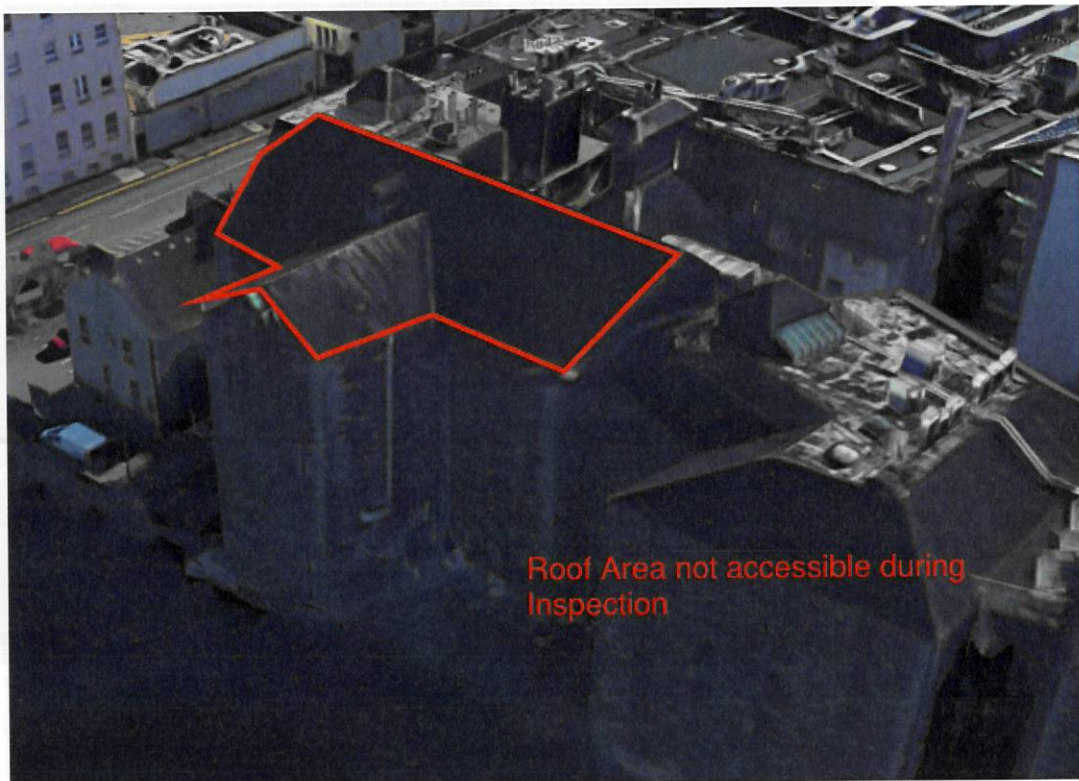
Figure 2: Area Not Accessible During Inspection

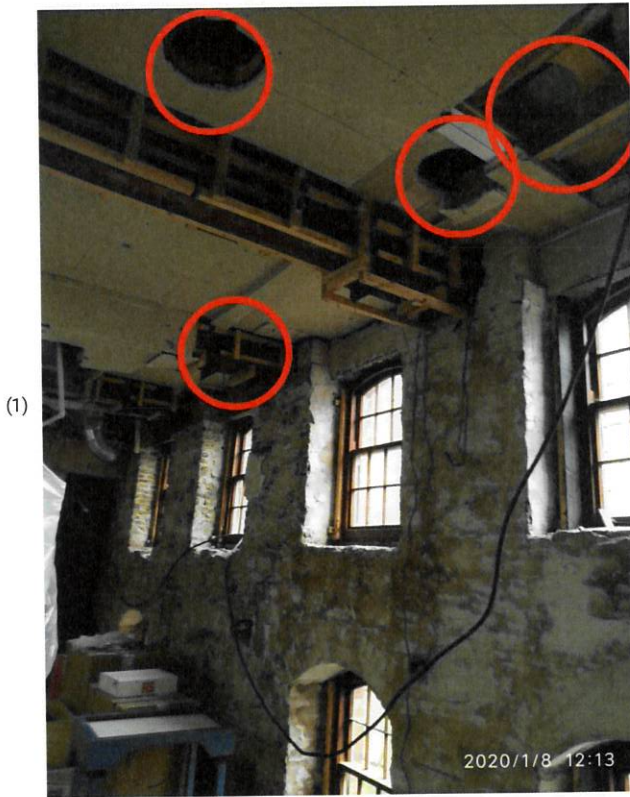
UccT_SiteVisi_200109202600_1.jpeg

Holes in ceiling. Masonry is in generally good condition apart from water staining from water ingress. It is noted that further investigation will be required to confirm, as survey is based on visual inspection only and no destructive testing has been carried out.

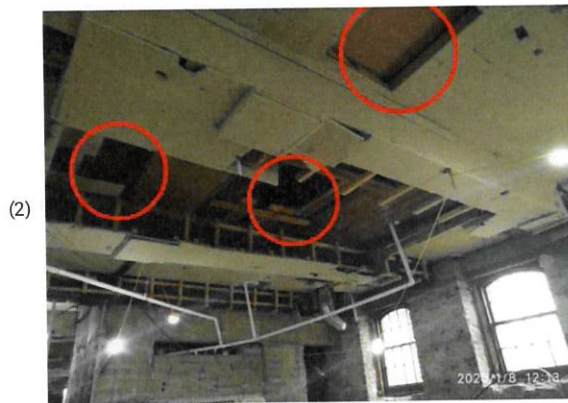
UccT_SiteVisi_200109202559_7.jpeg

Holes in third floor. Masonry walls are generally in good condition with no adverse signs of water damage apart from. Water stain.

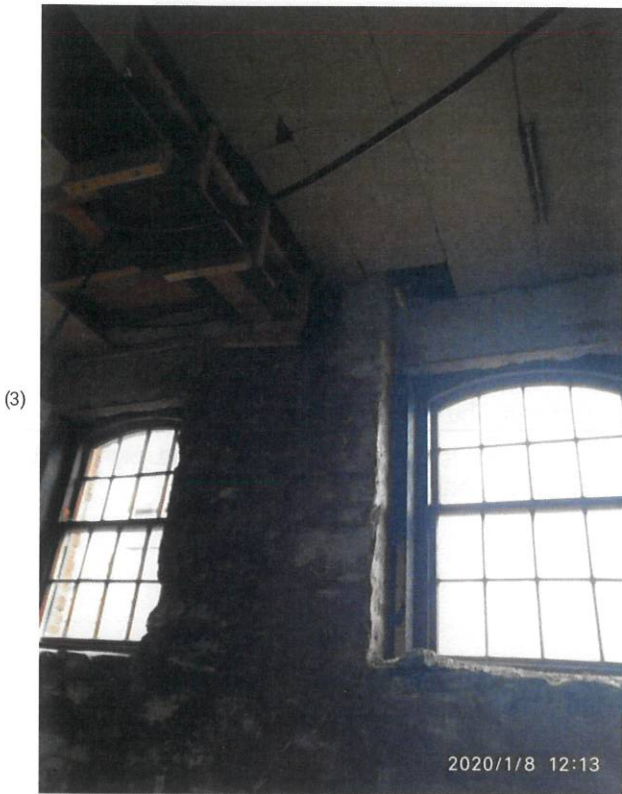
UccT_SiteVisi_200109202559_9.jpeg

Masonry in general good condition with no adverse signs of water damage apart from water stain.

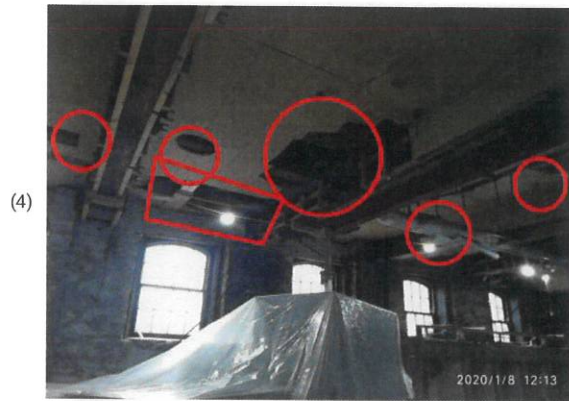
UccT_SiteVisi_200109202600.jpeg

Holes in ceiling.

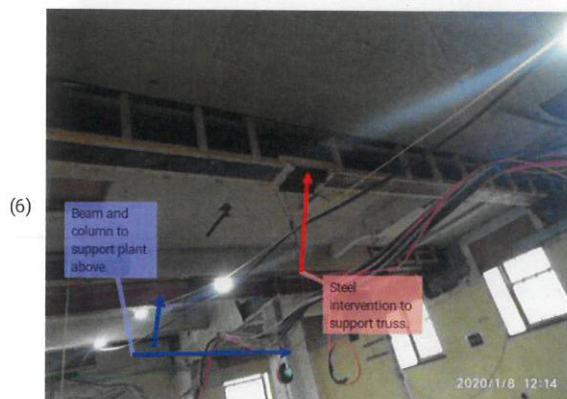
UccT_SiteVisi_200109202559_3.jpeg

Steel work installed to support existing timber truss.

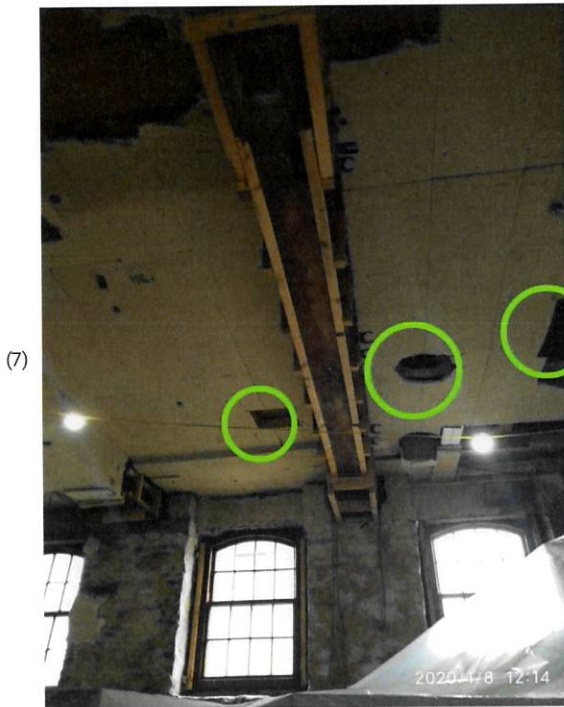
UccT_SiteVisi_200109202559_4.jpeg

Underside of truss. No adverse deflection or warping out of plane. Truss is in good repair.

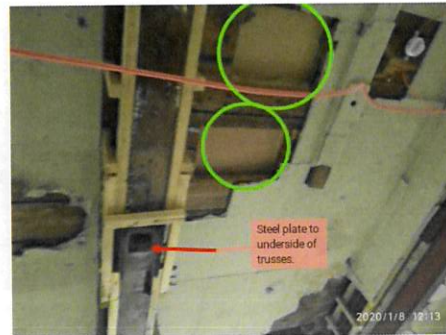
UccT_SiteVisi_200109202559_5.jpeg

Intervention to trusses. Steel plate noted. Significant openings noted in underside of 3rd floor.

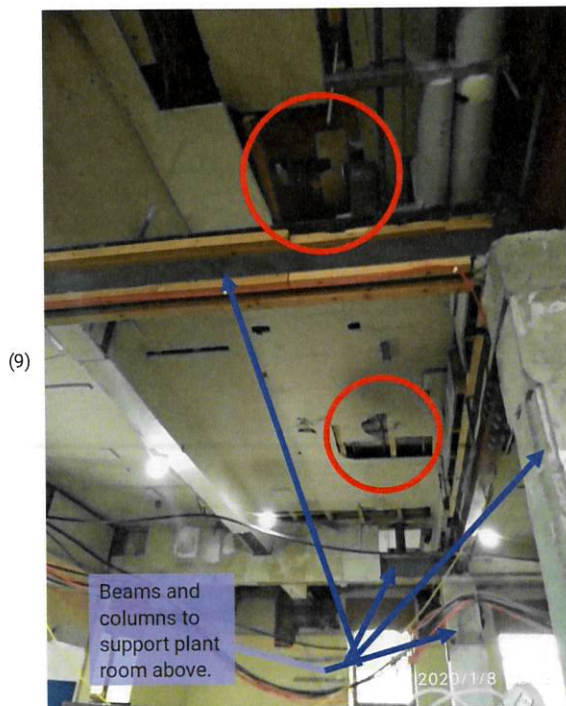
UccT_SiteVisi_200109202559_6.jpeg

Beams and columns to locally support plant room above. Holes noted in ceiling.

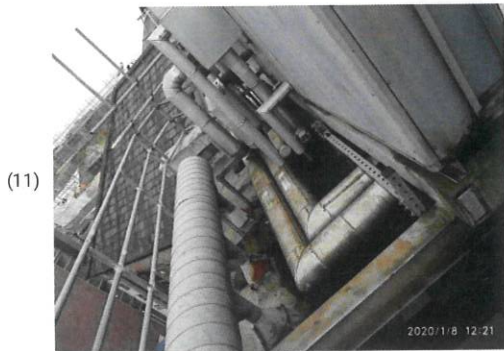
UccT_SiteVisi_200109202555_8.jpeg

Plant to be removed.

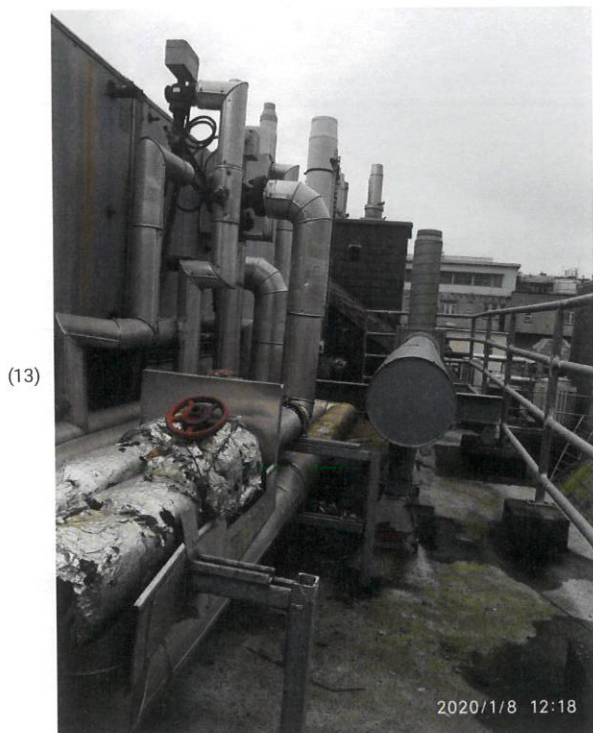
UccT_SiteVisi_200109202558_3.jpeg

Plant to be removed.

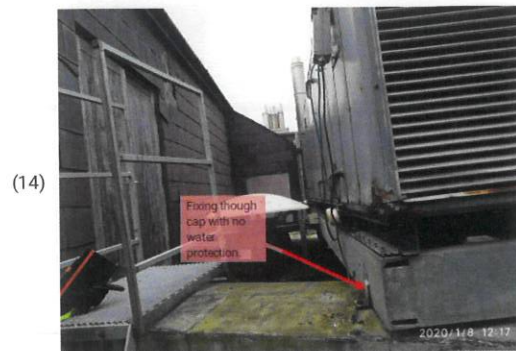
UccT_SiteVisi_200109202559.jpeg

Fixings of plant through cap of upstand.

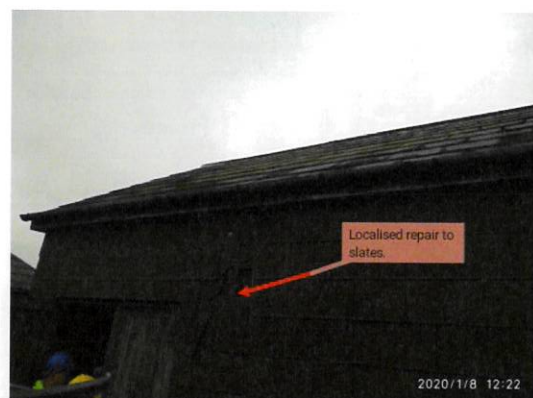
UccT_SiteVisi_200109202555_7.jpeg

Roof above enclosed plant area in reasonable condition. Minor repairs to slates required. No sagging in timber rafters noted in this area. Slates to check to be repaired.

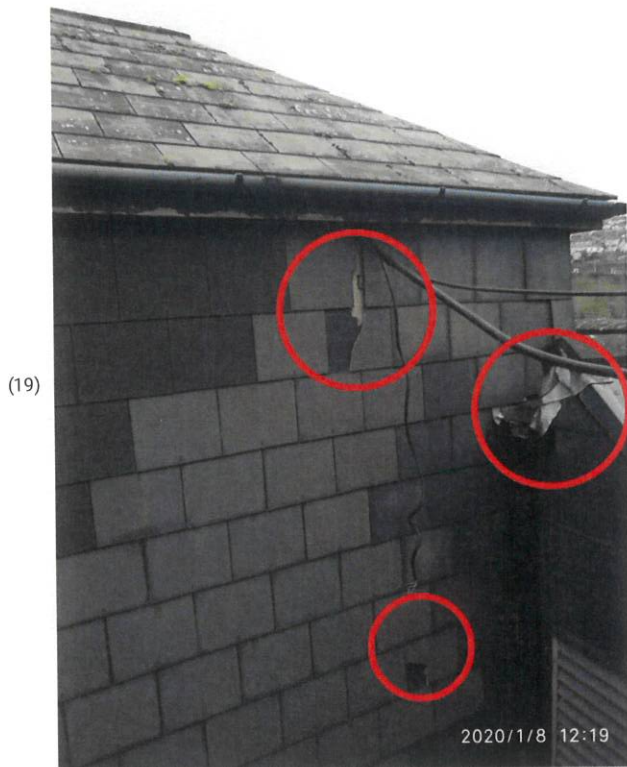
Created: Thu 09 Jan 20:25 2020
Localised repair to roof cheek.

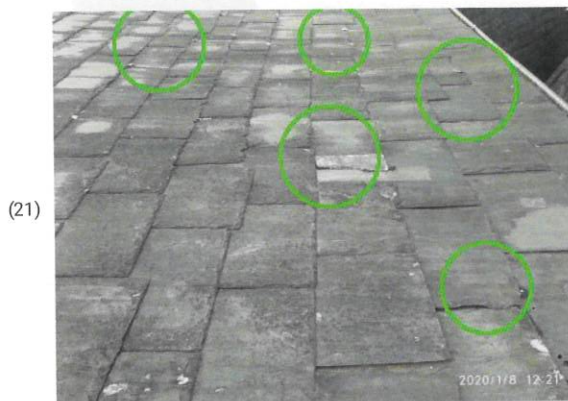
Created: Thu 09 Jan 20:25 2020
Slates require repair. Where slates need repair. Rafter to be closely inspected for signs of water damage and repaired if required.

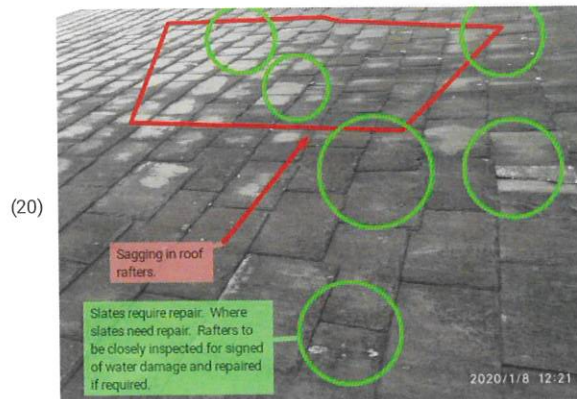
Created: Thu 09 Jan 20:25 2020
Sagging in roof rafters noted in mid section of roof.

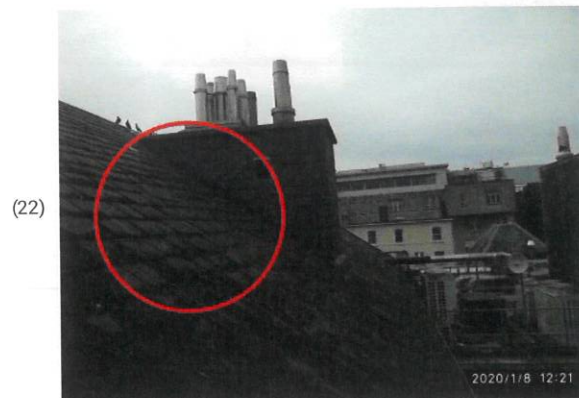
Created: Thu 09 Jan 20:25 2020
Sag noted in rafters.

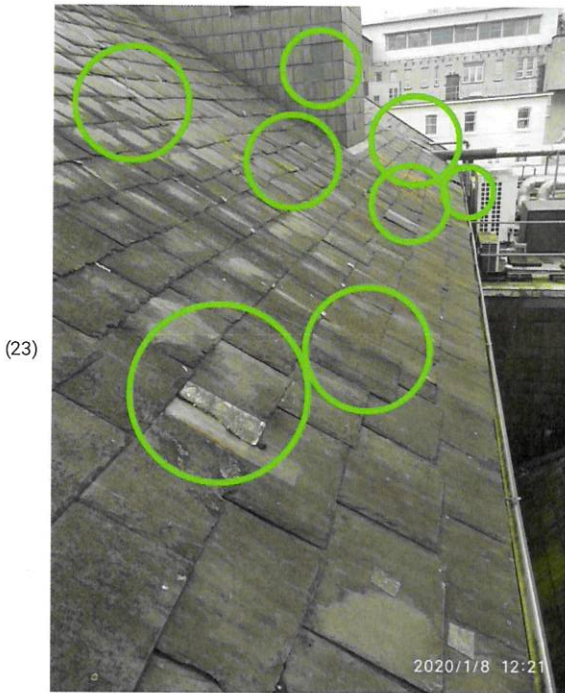
UccT_SiteVisi_200109202556_3.jpeg

Slates require repair. Where slates need repair. Rafters to be closely inspected for signs of water damage and repaired if required.

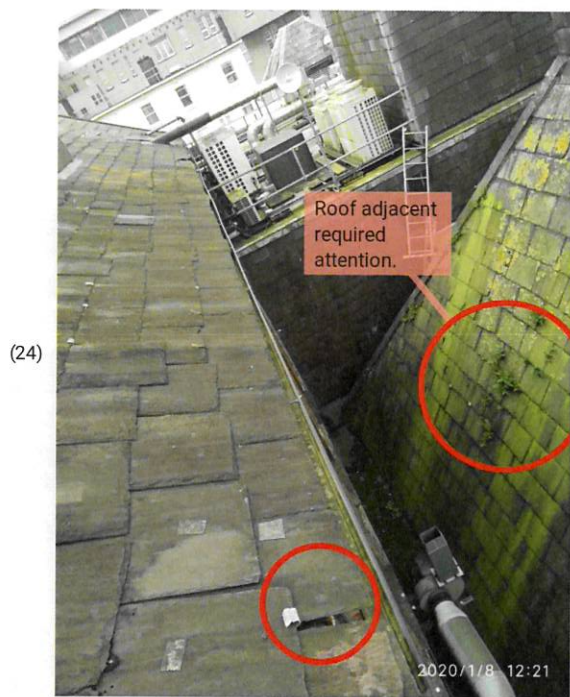
UccT_SiteVisi_200109202556_4.jpeg

Roof adjacent required cleaning and repair to avoid similar works as per phase 3a

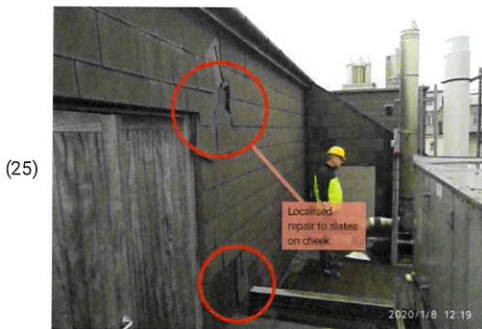
UccT_SiteVisi_200109202557.jpeg

Localised repair to slates on cheek.

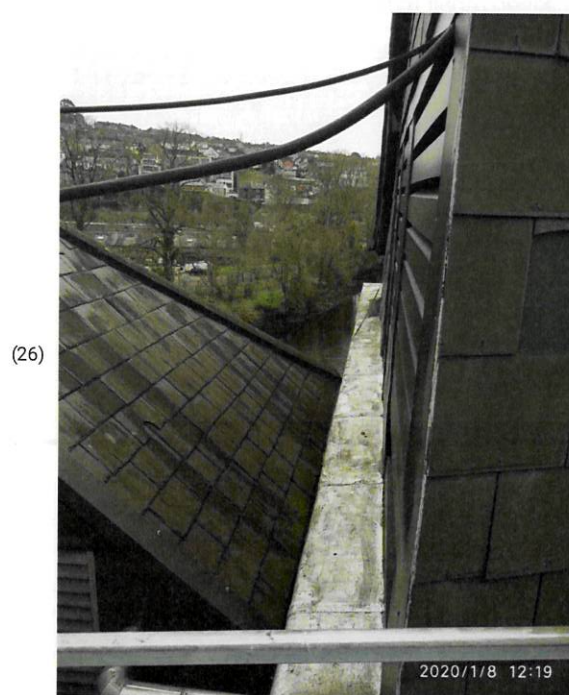
UccT_SiteVisi_200109202558.jpeg

Elevation in good repair. No access to roof from river side.

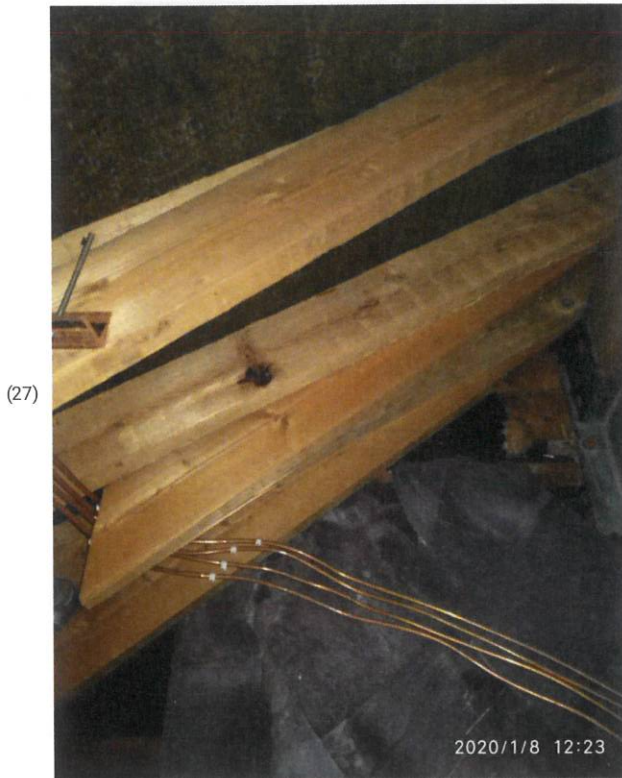
UccT_SiteVisi_200109202555_1.jpeg

New roof over internal plant has been constructed with limited consideration to traditional method.

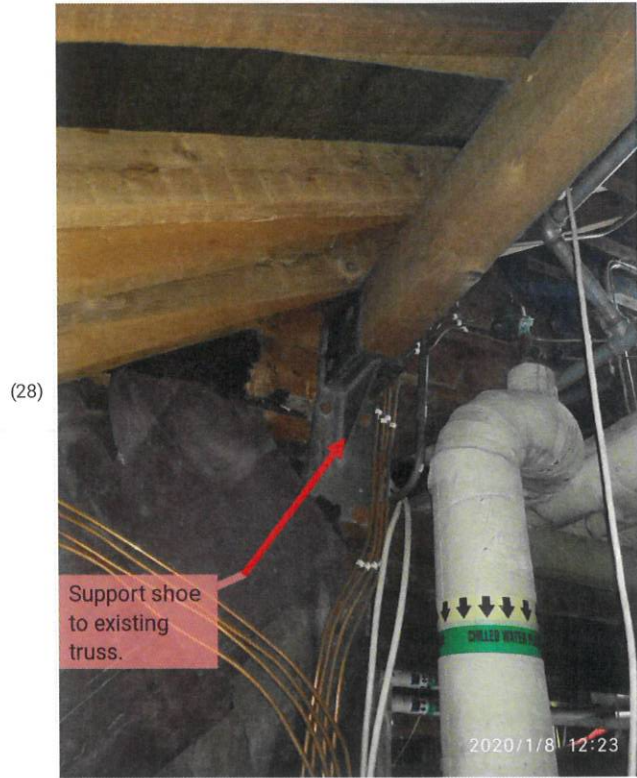
UccT_SiteVisi_200109202555_2.jpeg

Plant to be removed. Support shoe fixed to existing truss.

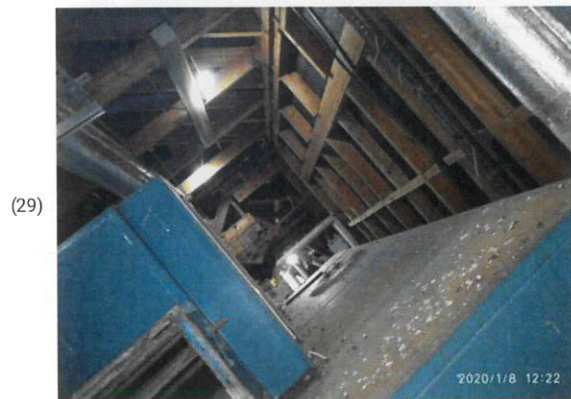
UccT_SiteVisi_200109202555_3.jpeg

Infill study wall to form cheek of dormer roof. Timber is in good condition with limited repair required.

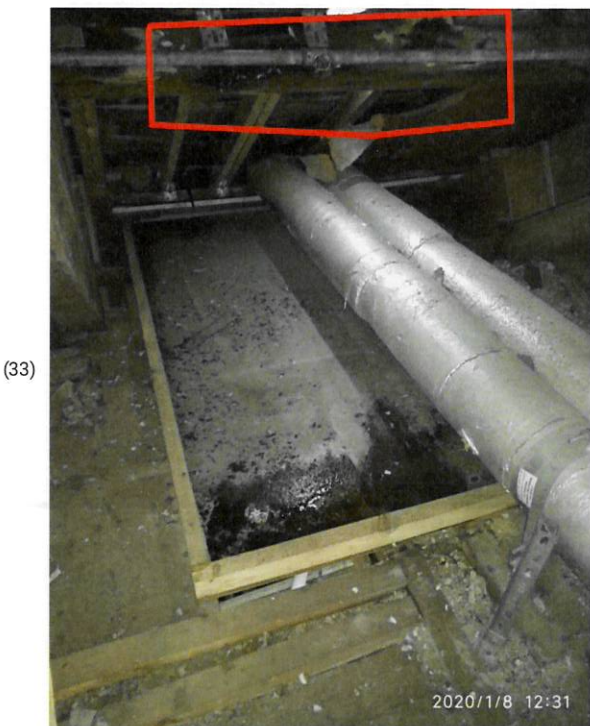
UccT_SiteVisi_200109202554.jpeg

Extensive watering rest with significant rot in timber rafters. Purlins are affected by the rot but are possibly salvageable with intervention strategy.

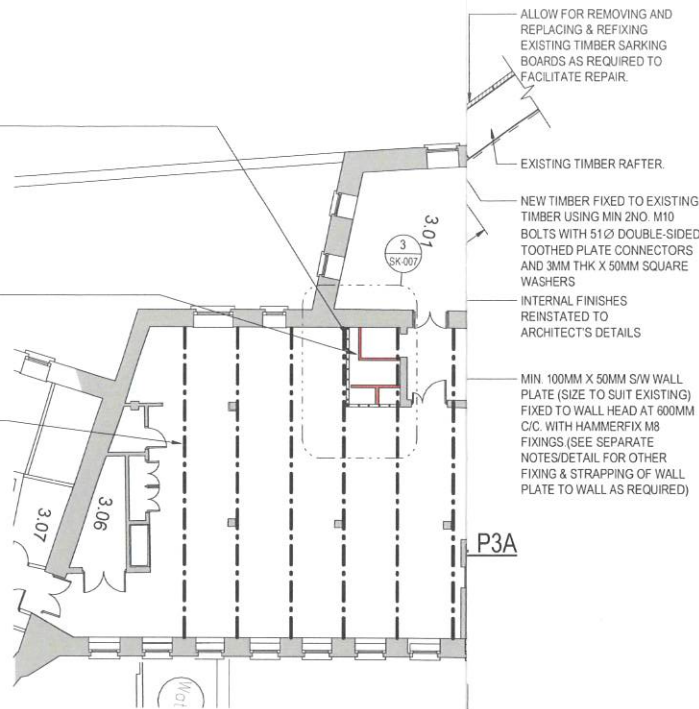
SAG HAS BEEN IDENTIFIED OF RAFTER ON SITE. RAFTERS TO BE STRENGTHEN IN THIS AREA.

ALLOW FOR REMOVING AND REPLACING & REFIXING EXISTING TIMBER SARKING BOARDS AS REQUIRED TO FACILITATE REPAIR.

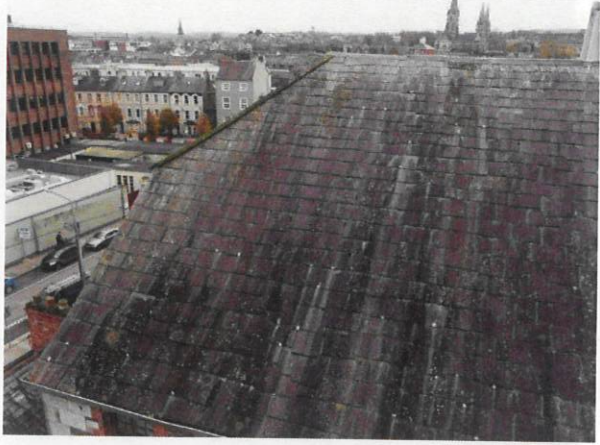
<p>This image shows the tile slippage of the northeast face of the roof. Evidence of slippage is clear and furthermore there are signs of repairs which has been carried out</p>

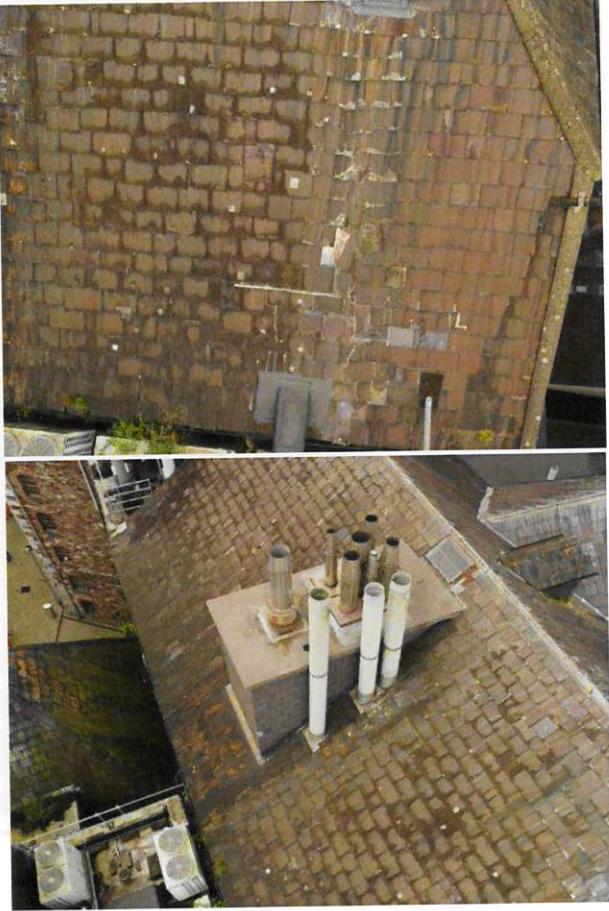
<p>This image shows the tile slippage of the South/East face of the roof. Evidence of slippage is pronounced and the area at the existing eaves shows significant water ingress within the roof space.</p>

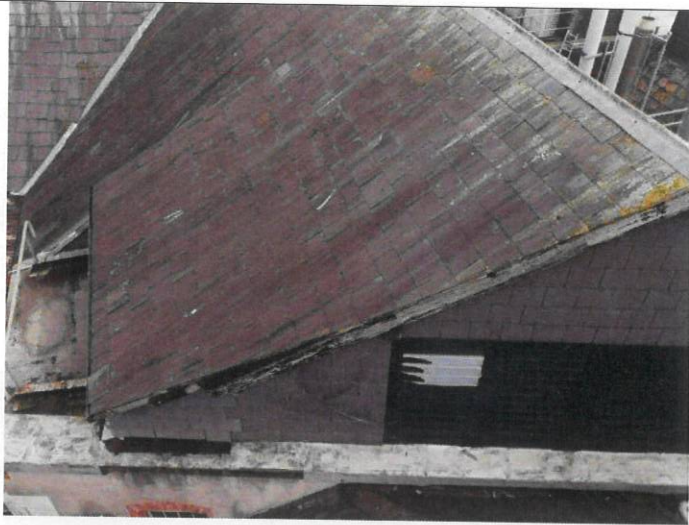
<p>Evidence of rotten damaged timbers requiring replacement. Existing gable is uninsulated also and should be rebuilt and insulated. New proprietary aluminium louvre with insect mesh to be fitted into new wall.</p>
<p>Fig. 5 Southwest plant area</p>

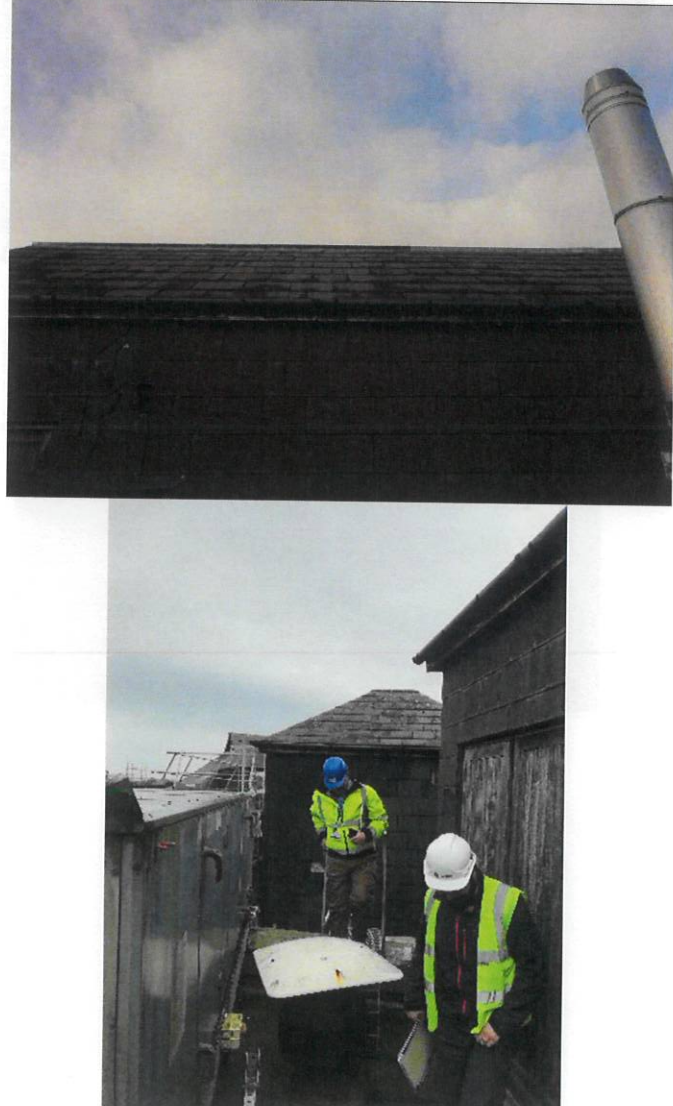
<p>Area of the original roof has been removed in the past and an area of plant and flat roof constructed. This area requires attention and should be rebuilt as wall is un-insulated. 'Truetone' slates are damaged and not in keeping with the general slating of the building.</p> <p>Slates are possibly asbestos are will require licenced removal and disposal.</p>

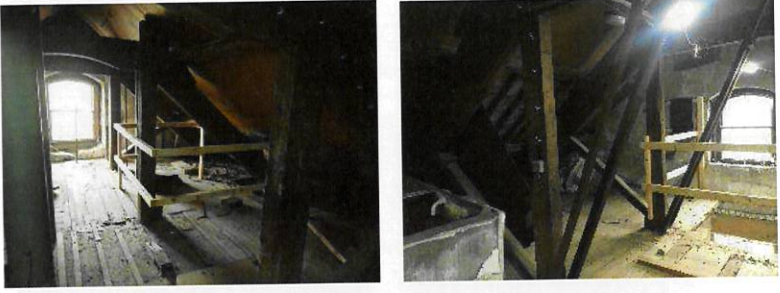
<p>Timber boarding within space require a degree of repair with some boarding loose and/or missing</p>
<p>Fig. 7 Internal spaces</p>

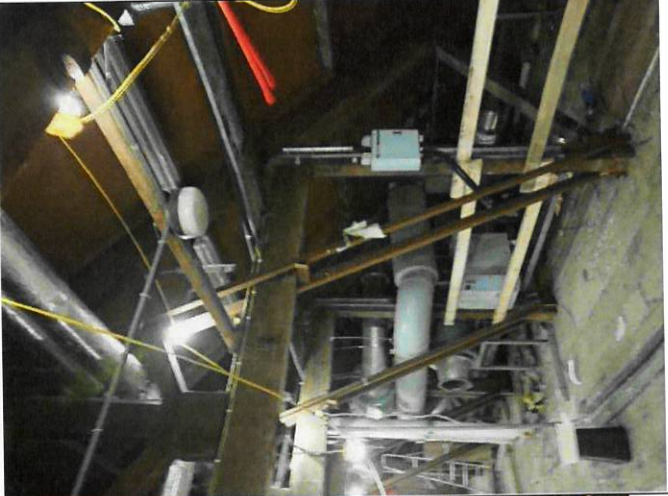
<p>Services and plant to be removed by another contractor prior to roof works commencing</p>
<p>Fig. 8 Internal spaces</p>

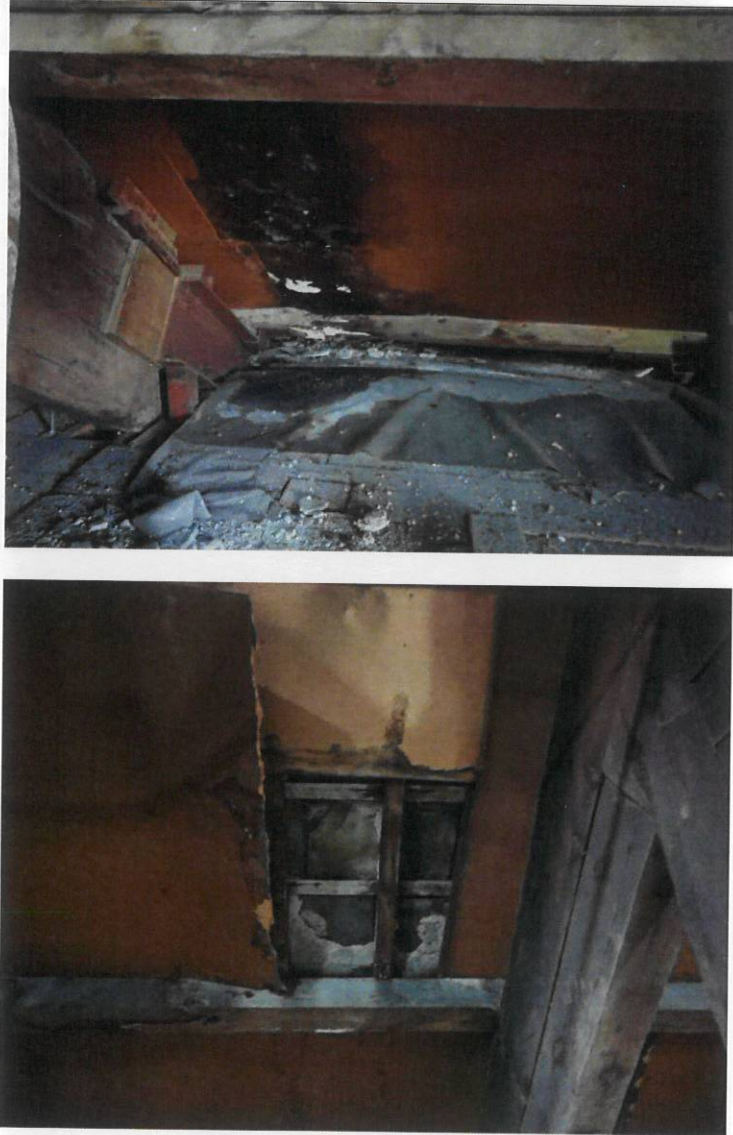
<p>Evidence of water ingress.</p>

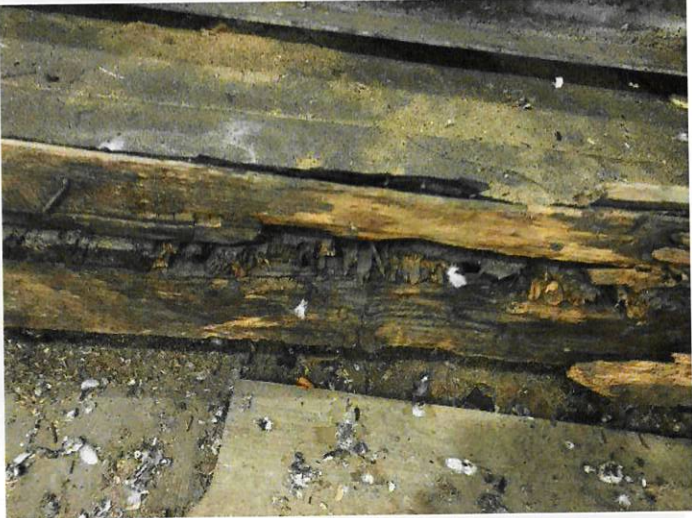
<p>Fig. 10 Rot Noted</p>

<p>Area of timber rot noted.to be treated/repared and/or replaced</p>
<p>Fig. 11 Masonry repairs required</p>

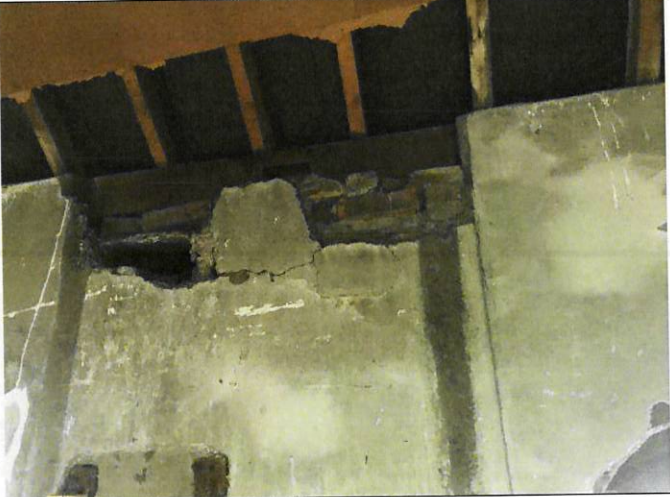
<p>It was notes around some of the window heads and at wallplate some masonry repairs are required</p>

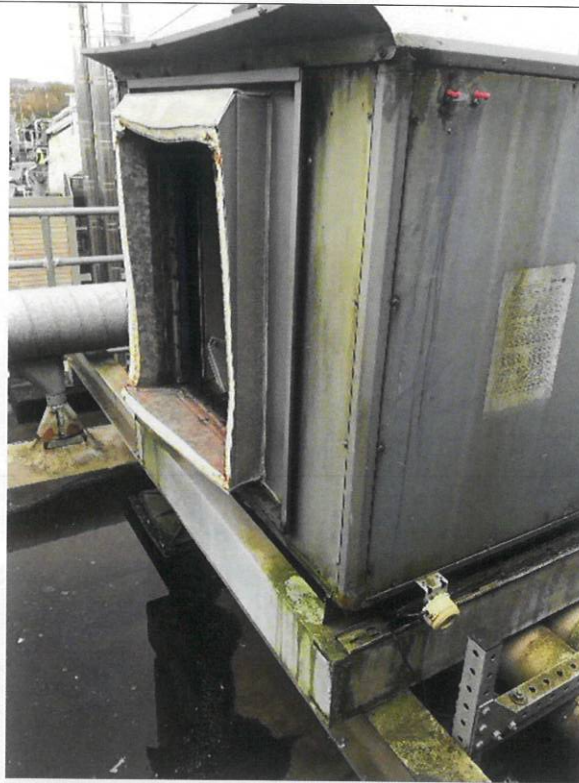
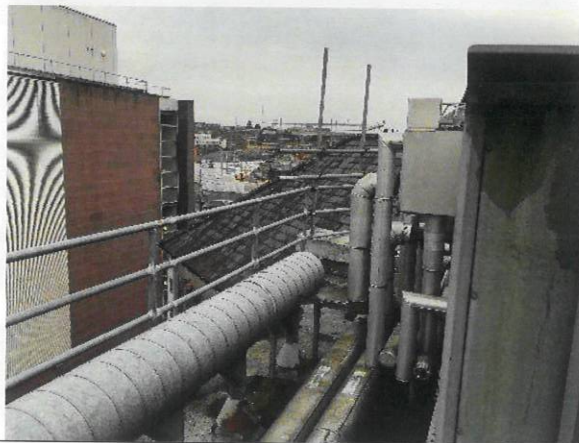
Fig. 12
Roof Plant

Existing plant to southwestern flat roof area to be removed and flat roof to be recovered.

Provision for a drop down area and an access hatch to 3rd floor area. 'Bilco Type 'D'' or similar approved 2.4mx2.4m access hatch.

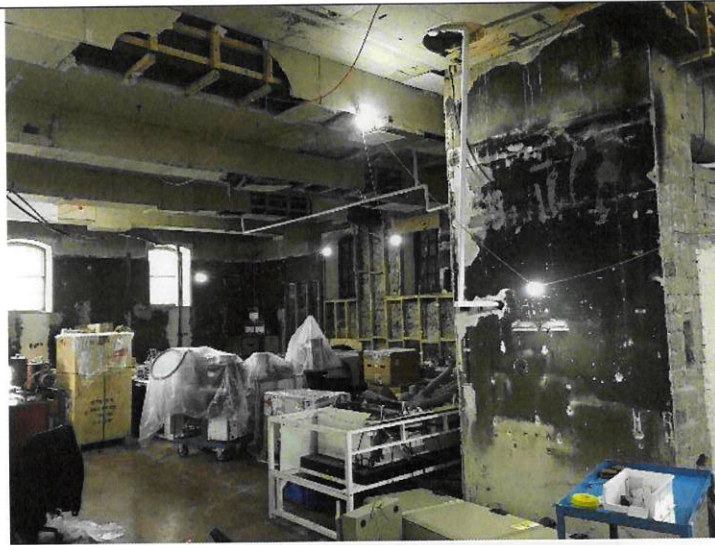
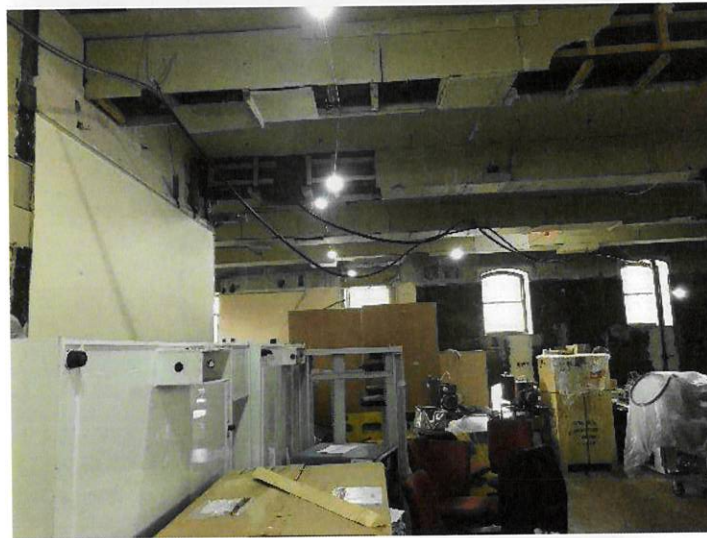
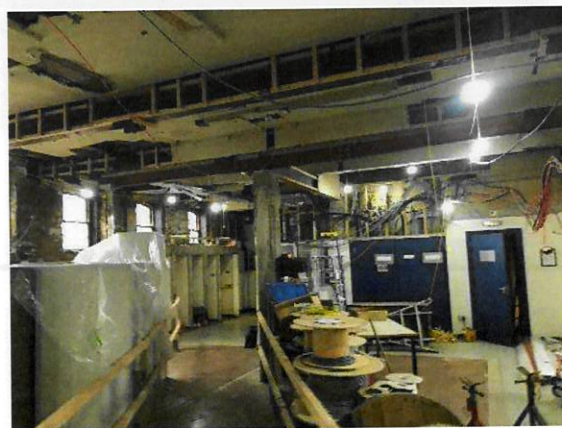
Fig.13
Fire
Ceilings

Fire board encasement to ceiling of level 4 requires attention

Fire protection to steel structure to be reinstated and openings in floors to be framed out with fire separation to floor above – refer to attached drawings

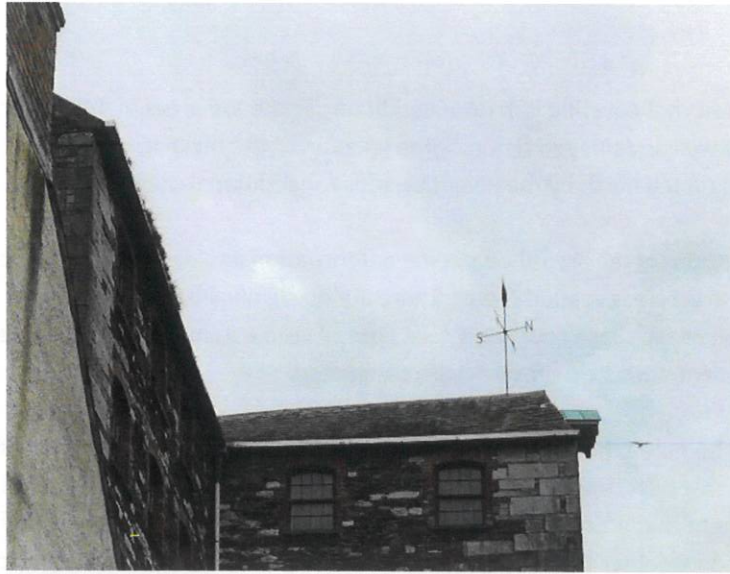
Fig.14
Gutters and
downpipes

Gutters overgrown and rusted and require replacement
